Effects of bank vegetation in waterways with special reference to bank erosion, shear strength, root density and channel hydraulics

**Effects of Bank Vegetation in Waterways with Special
Reference to Bank Erosion, Shear Strength, Root Density and
Channel Hydraulics**

**A thesis submitted to the Open University
for the Degree of Doctor of Philosophy
Biology Department
September 1992**

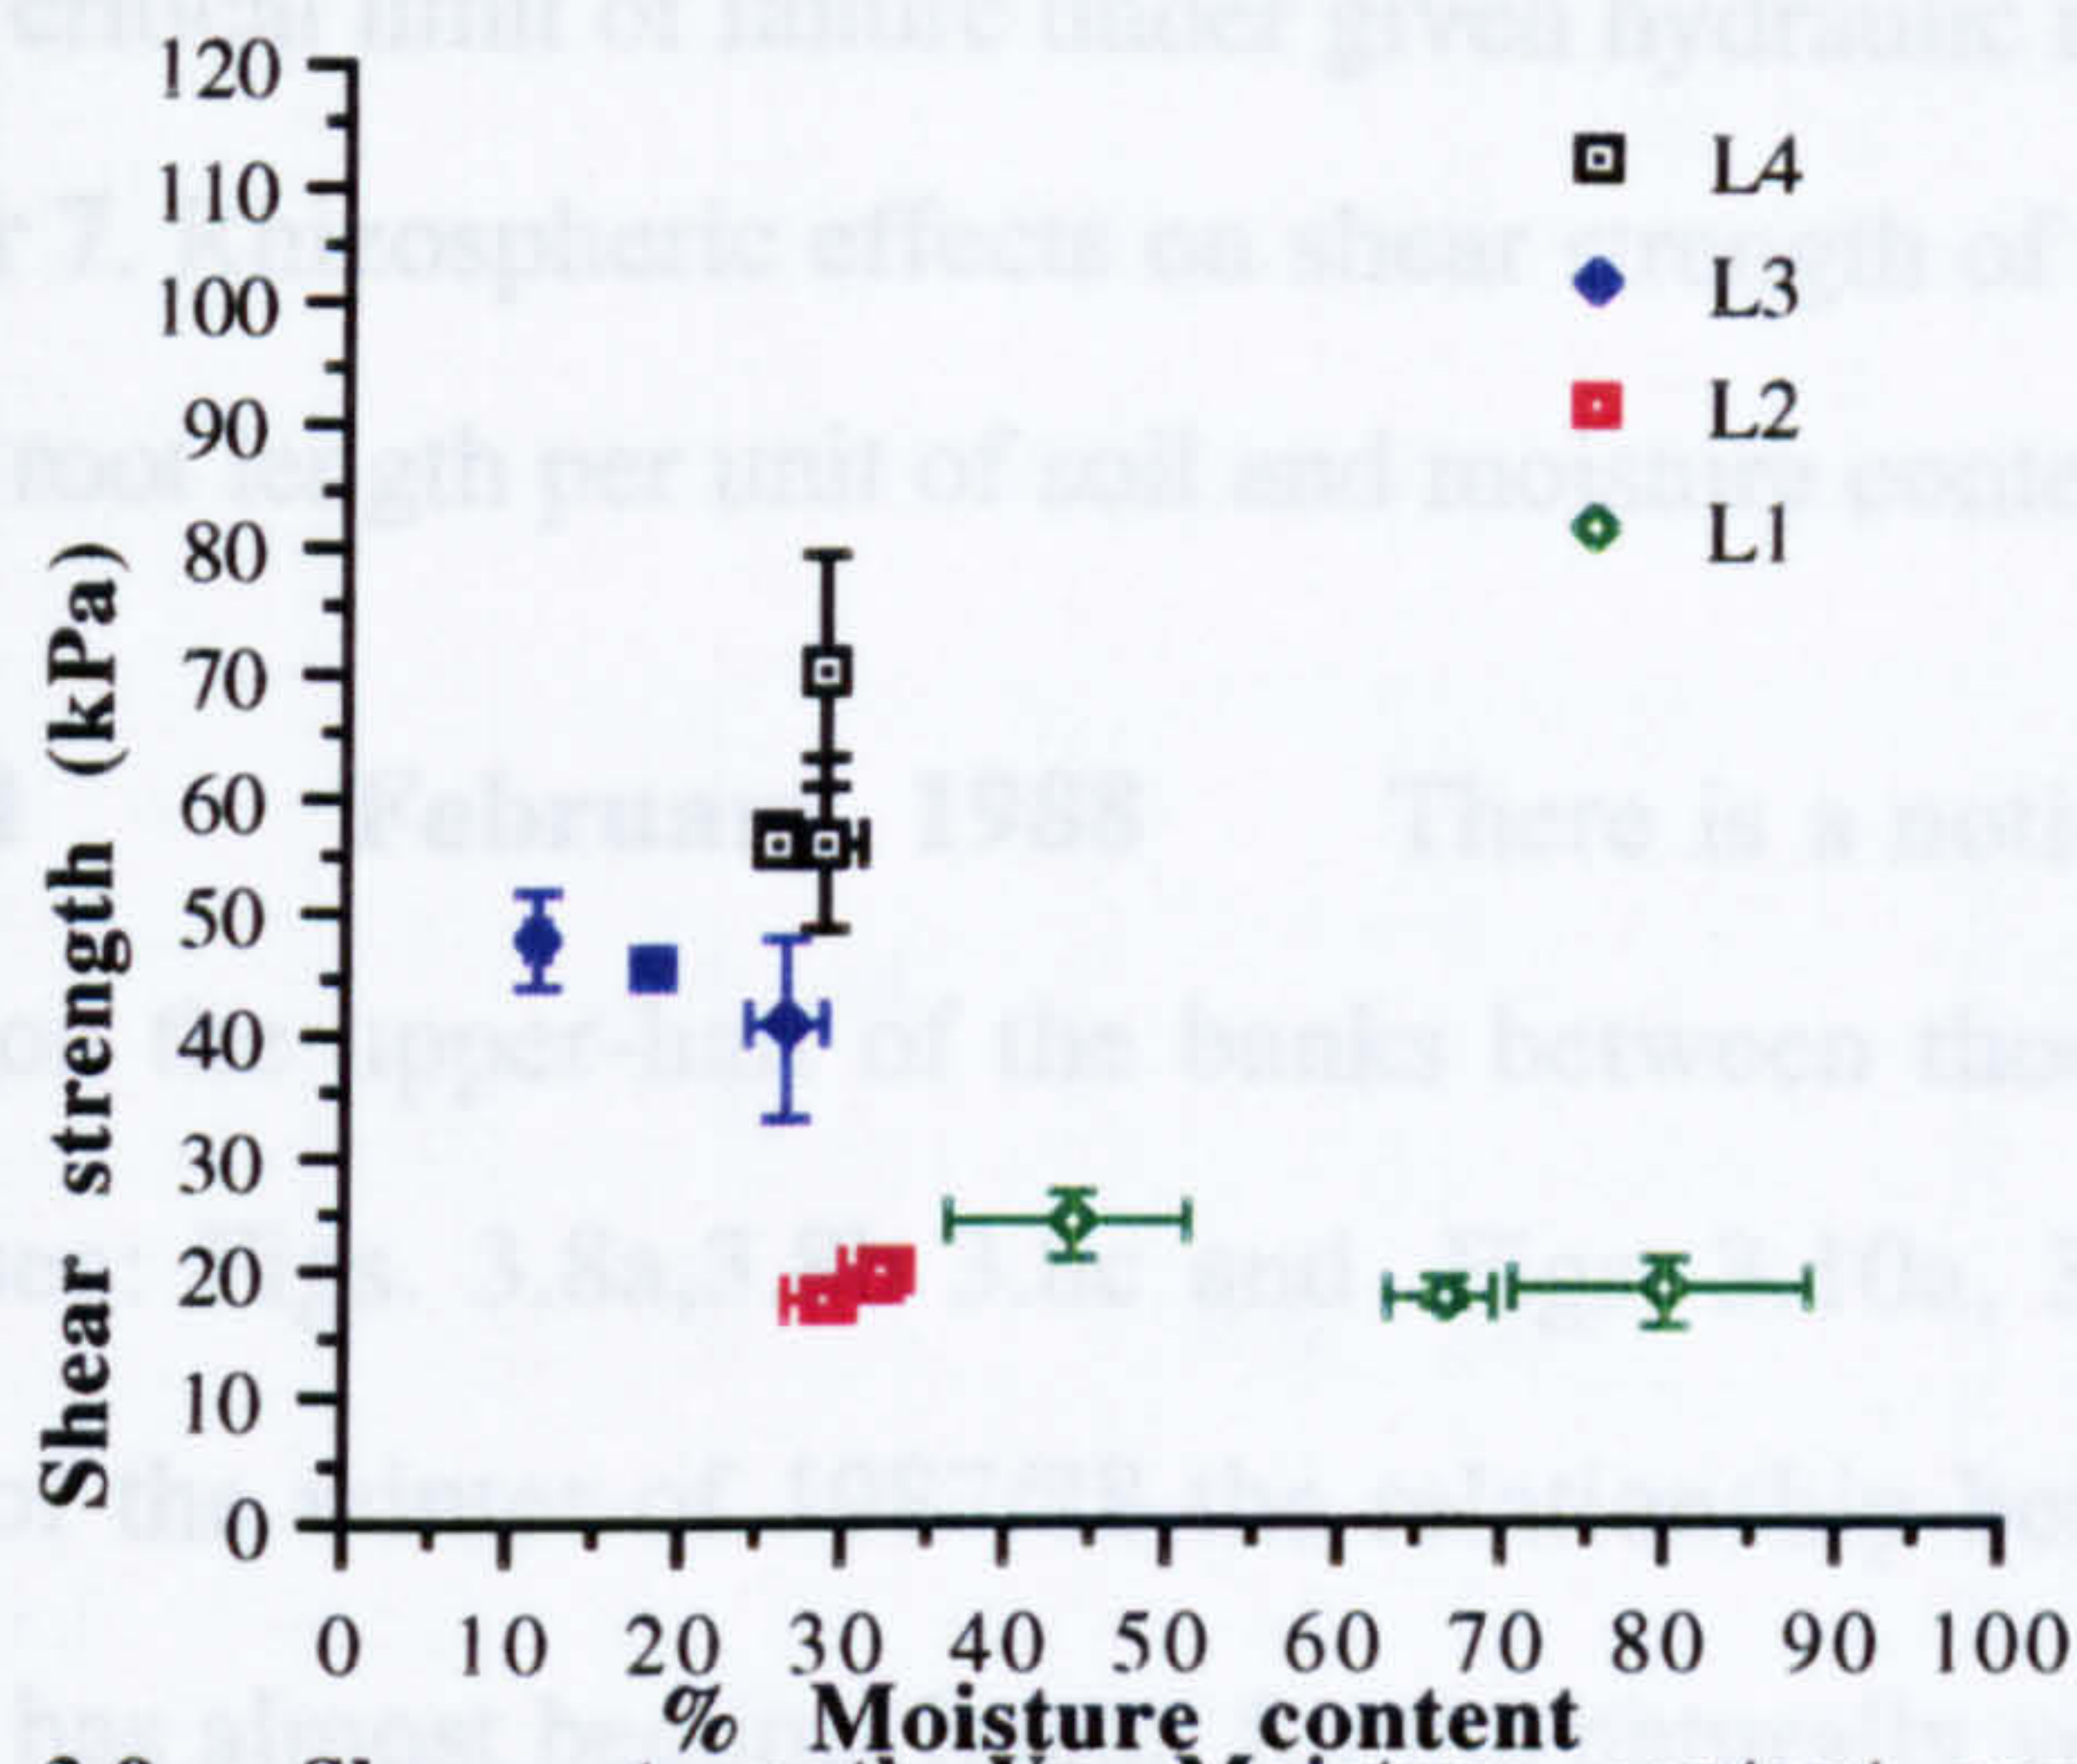
Fig. 3.9a: Shear strength Vs. Moisture content variations (August 1987)
Bare Banks

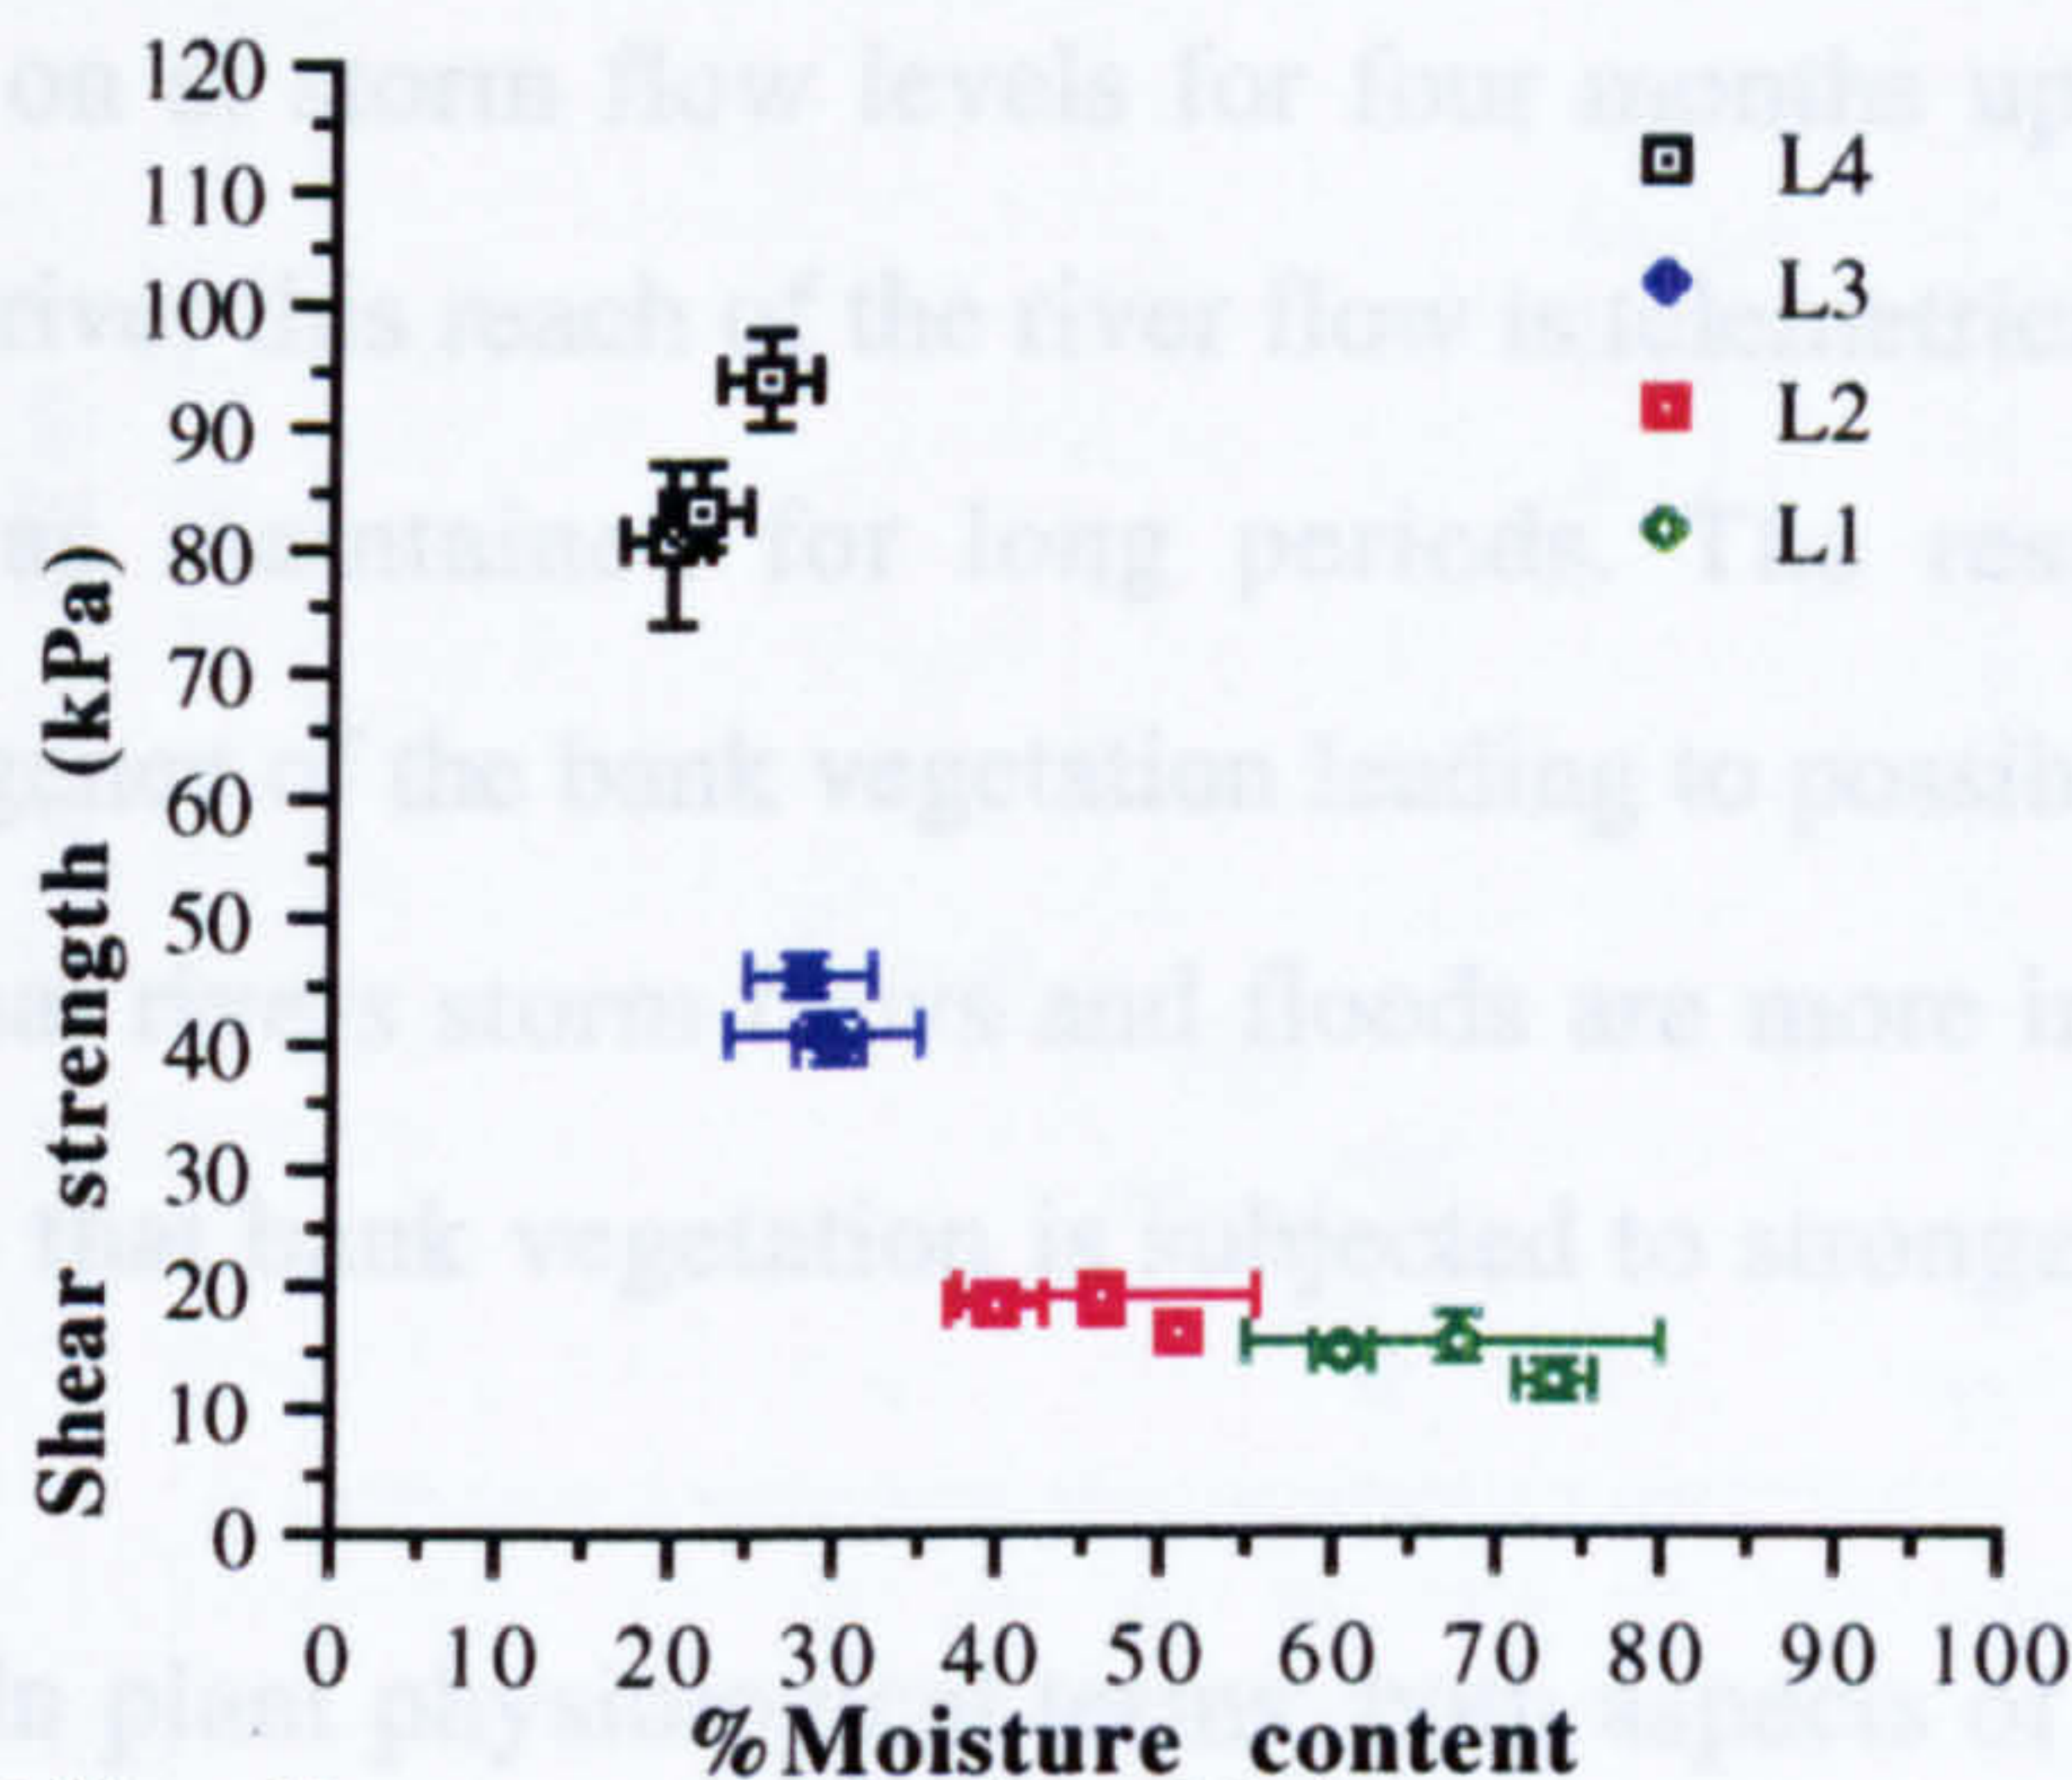
Fig. 3.9b: Shear strength Vs. Moisture content variations (August 1987)
Naturally vegetated banks dominated by *E. hirsutum*

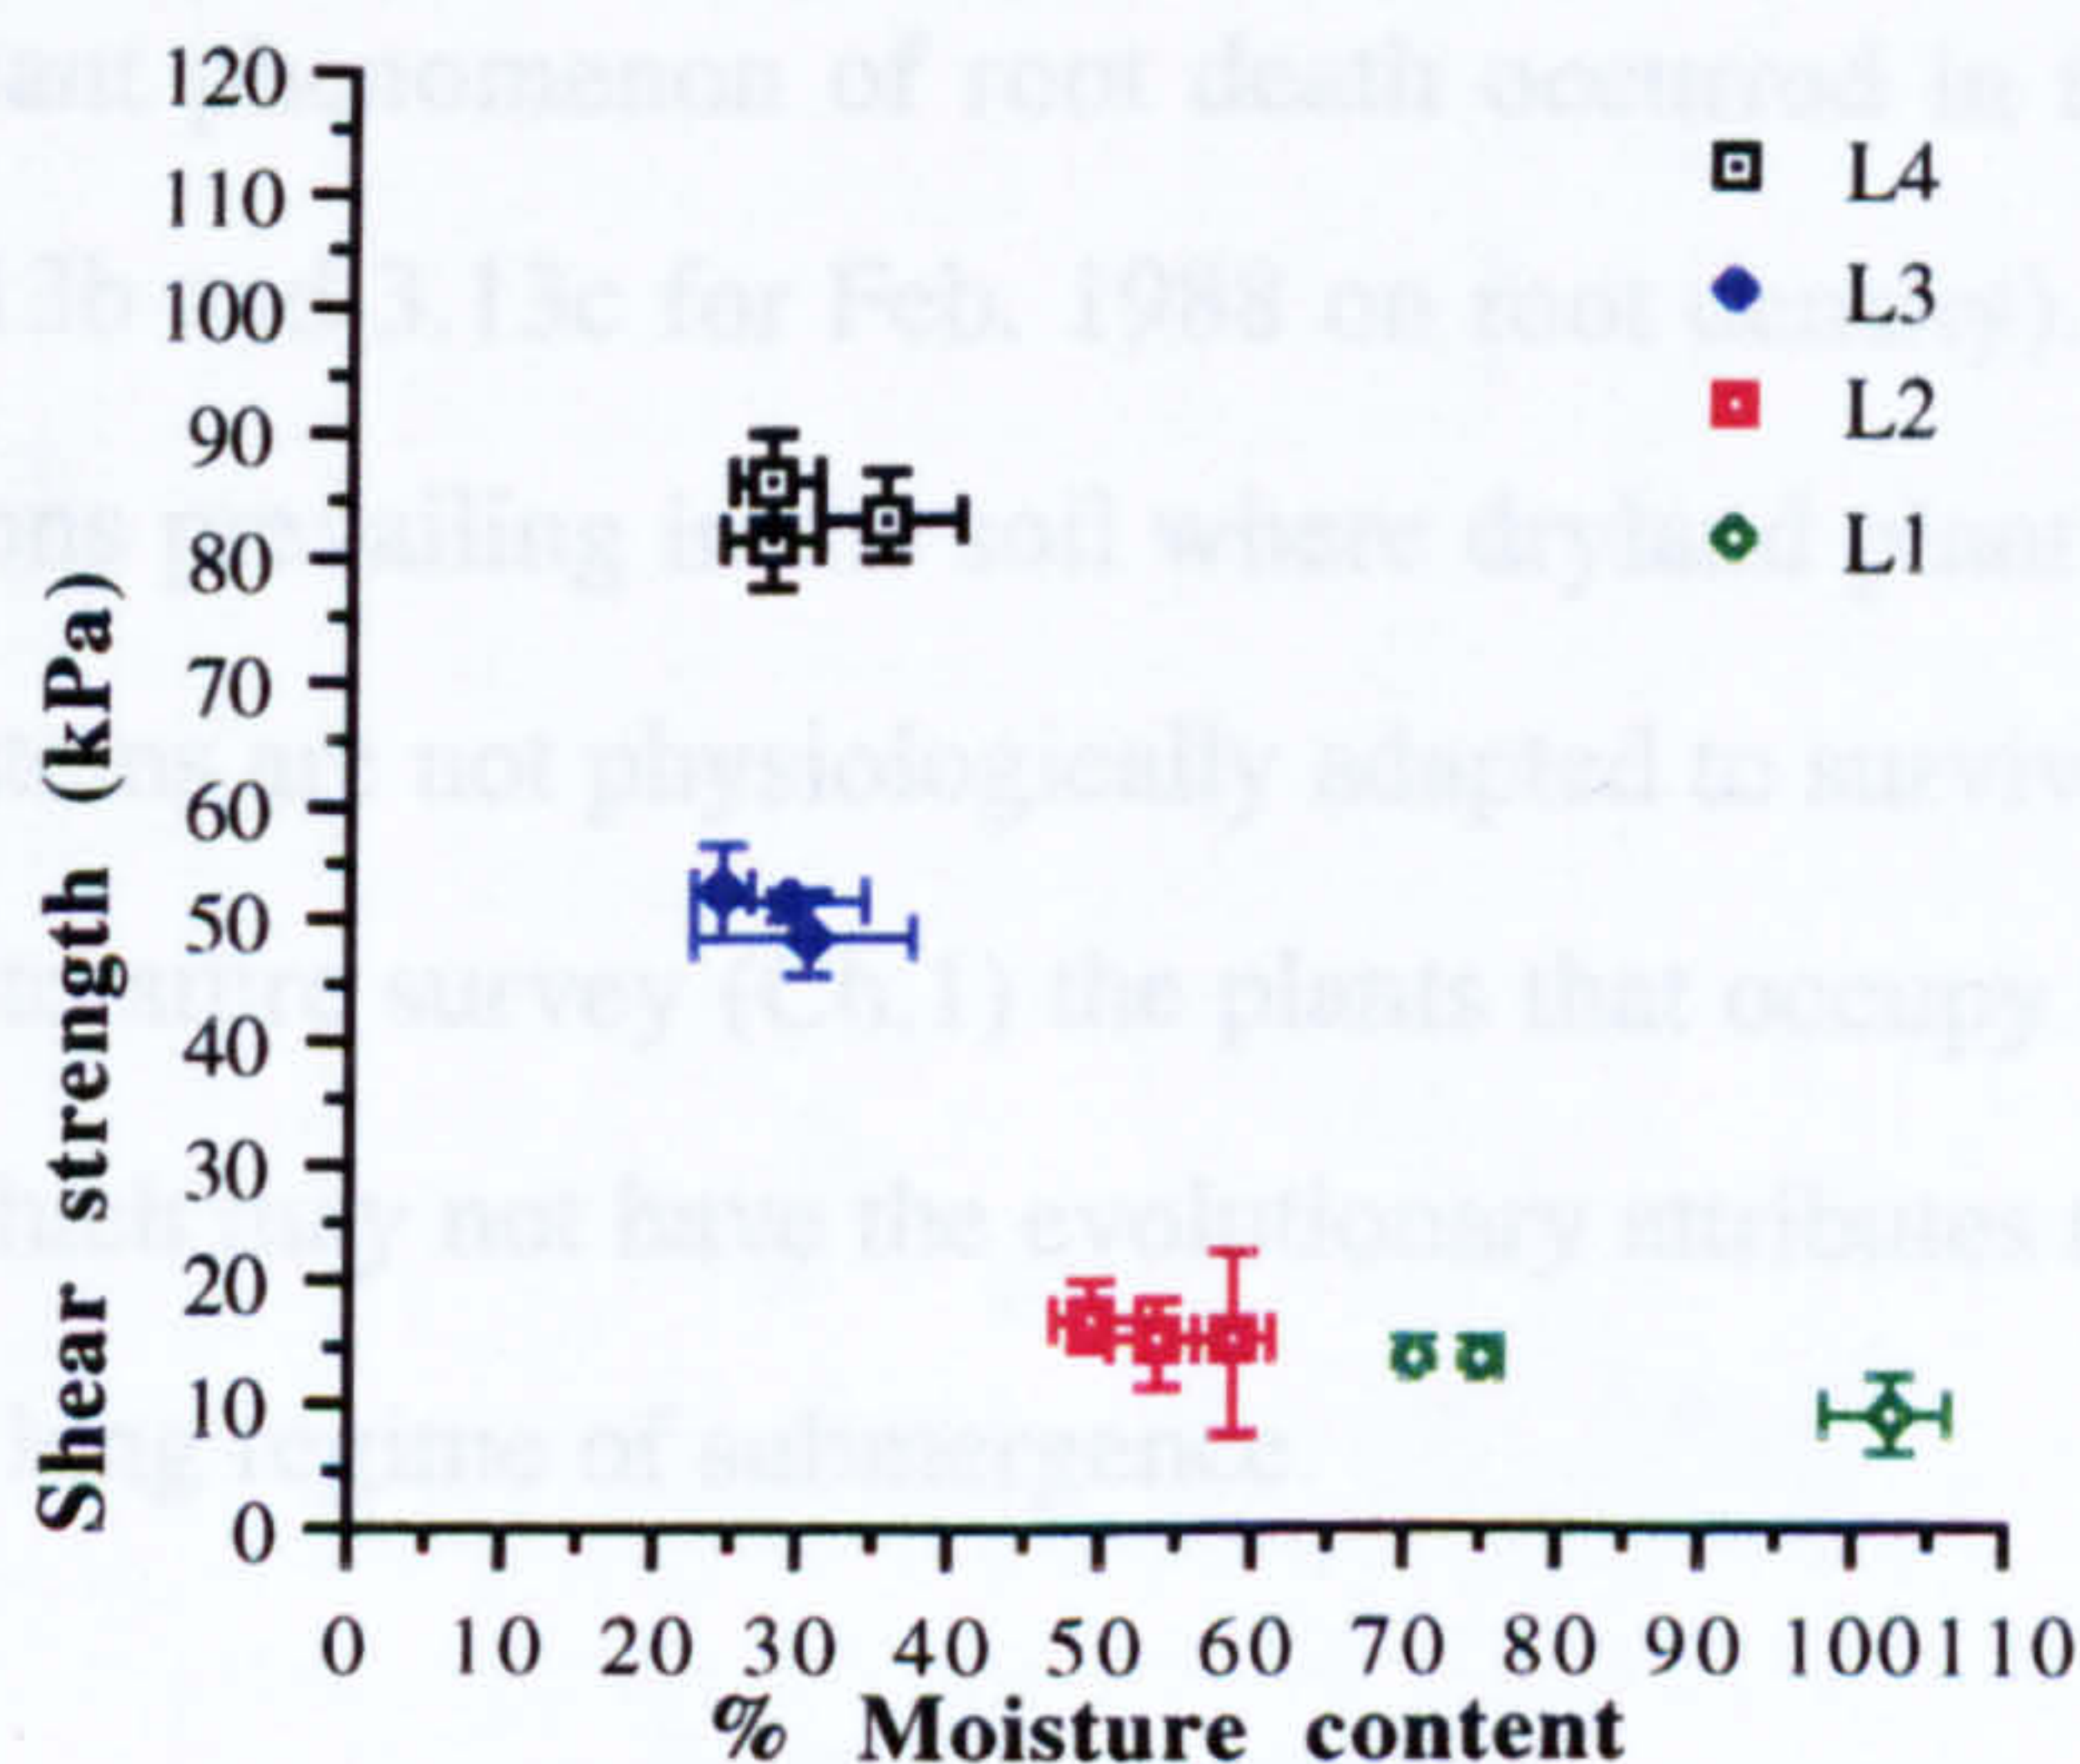
Fig. 3.9c: Shear strength Vs. Moisture content variations (August 1987)
Naturally vegetated banks dominated by *U. dioica*

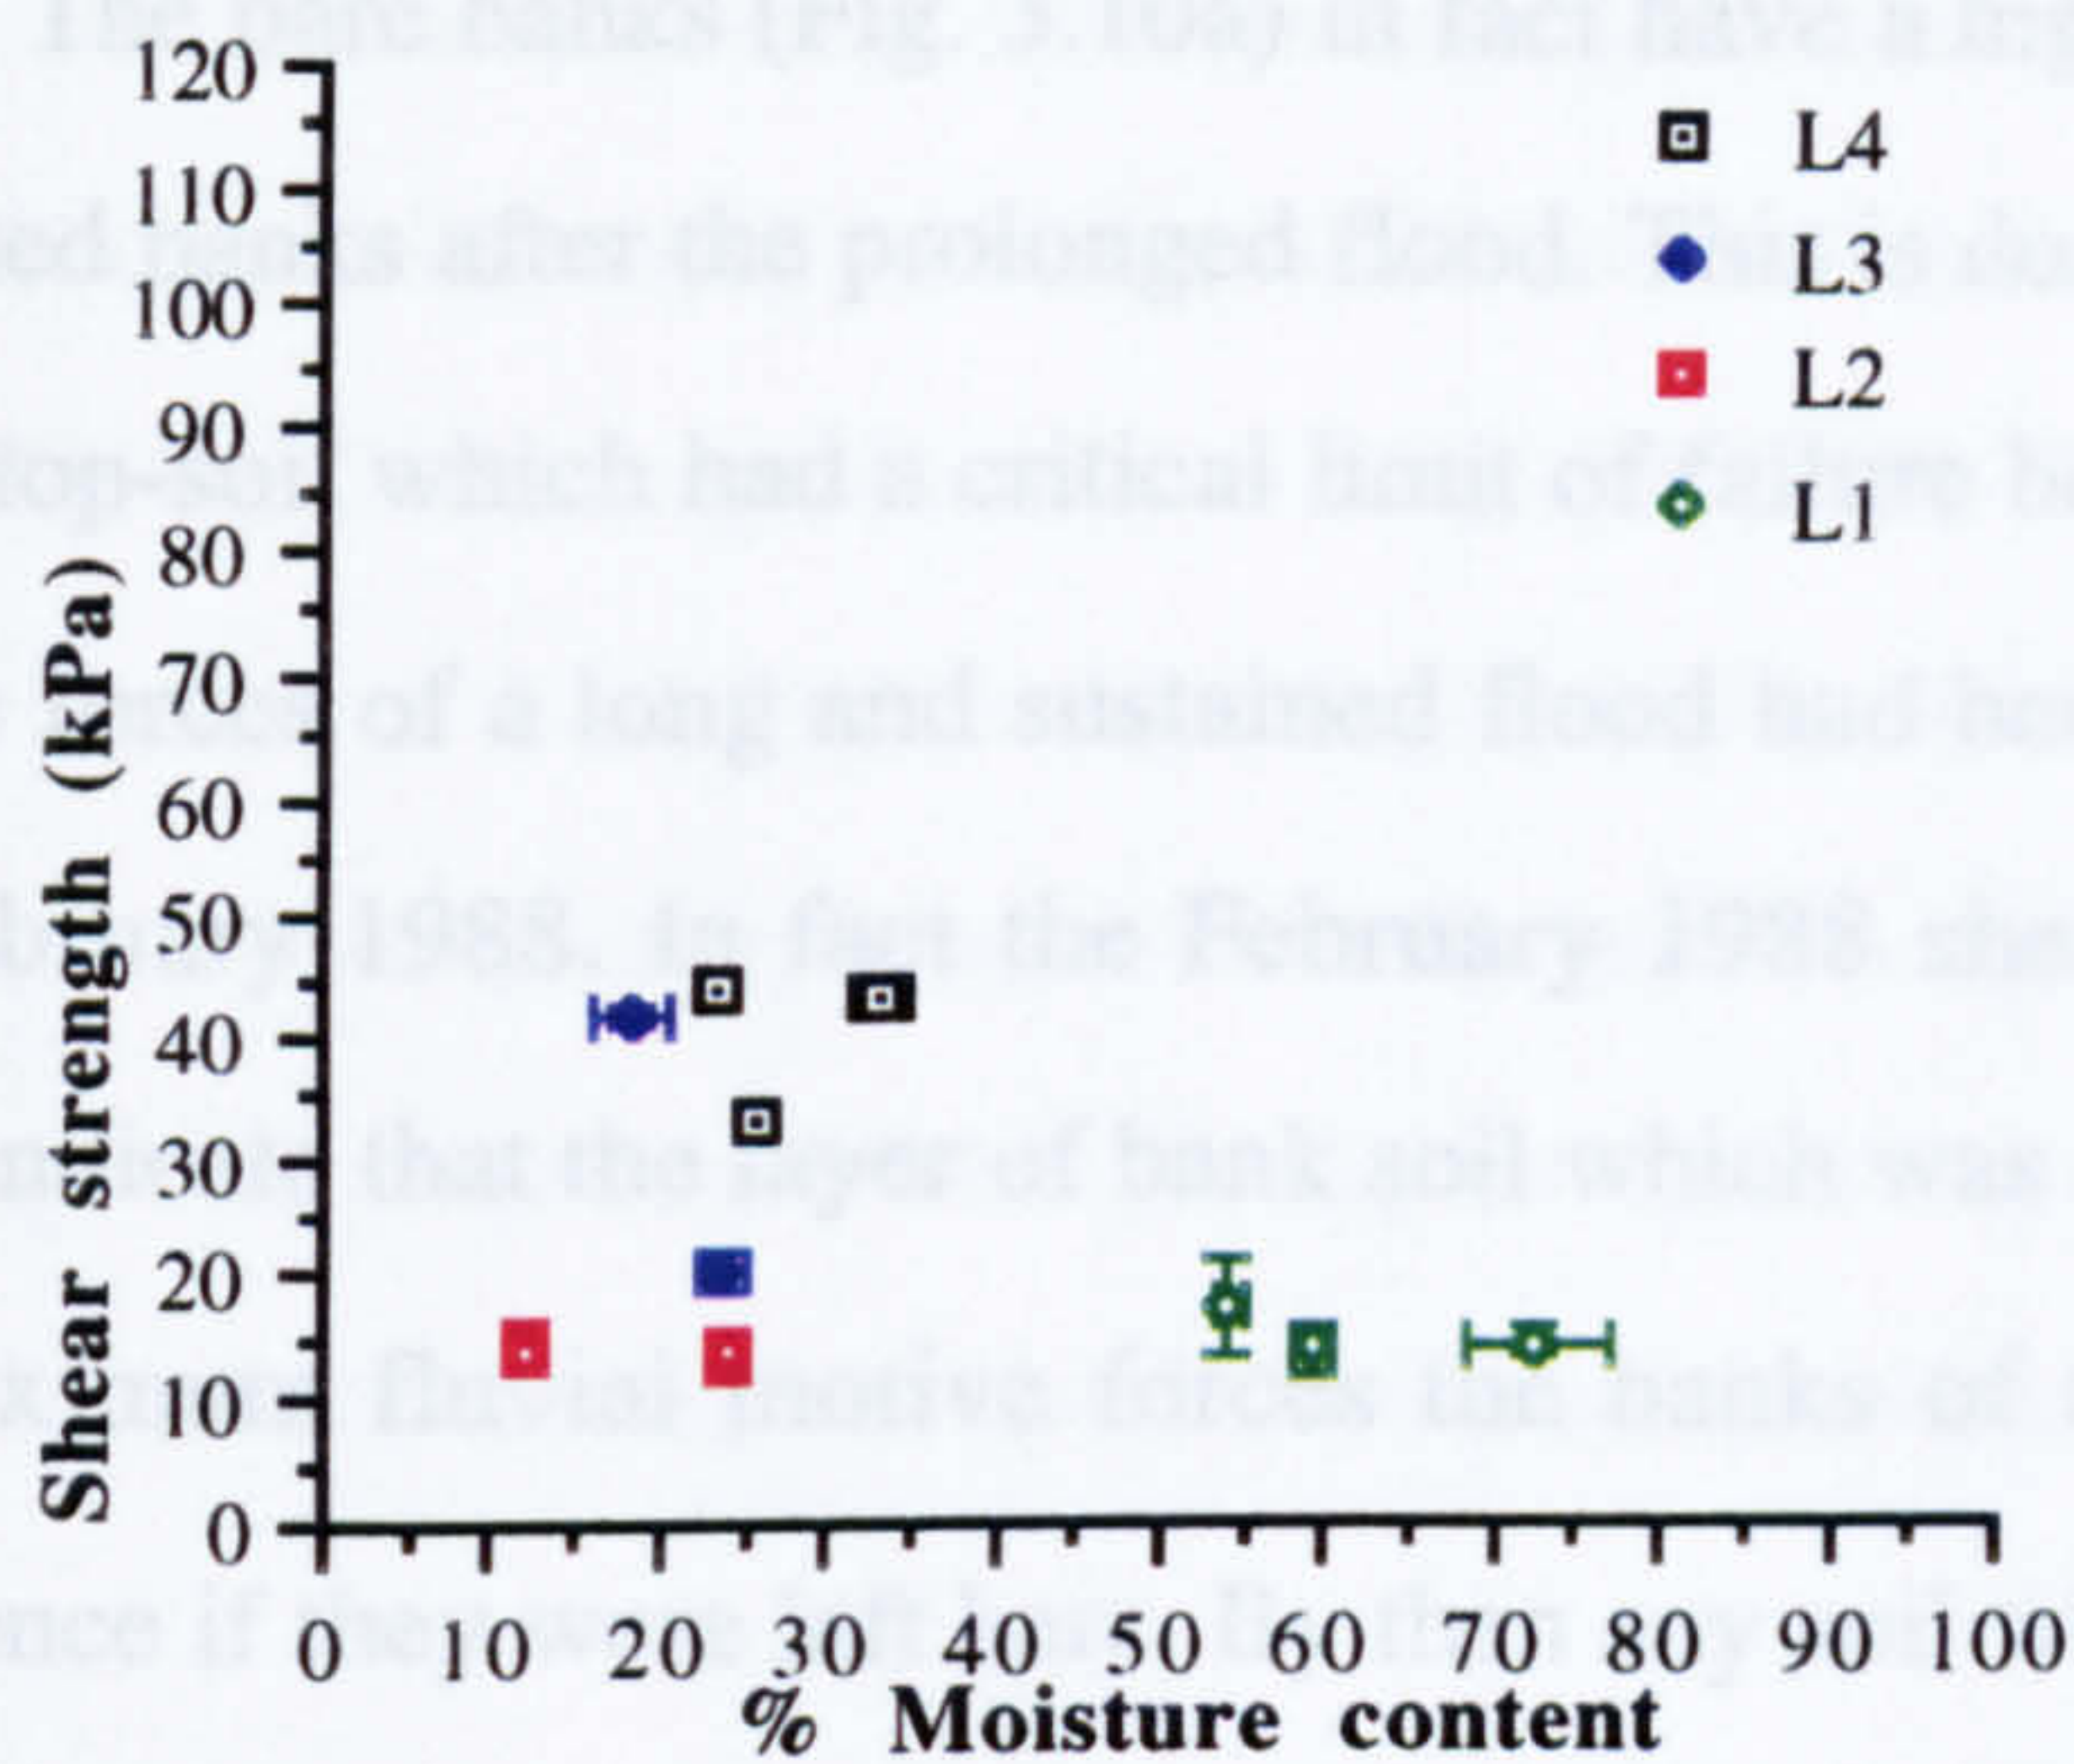
Fig. 3.10a: Shear strength Vs. Moisture content variations (February 1988)
Bare Banks

- i) long-term winter submergence associated with continuous long-term saturation of the upper banks lowers the shear strength of the Bare and naturally vegetated banks; such lowered values persist over the following months;
- ii) the lowering of shear strength values cannot be attributed to increases in moisture content of the banks as the measurements were carried out on sunny days with at least two to three previous days of continuous dry weather; In essence these measurements were not carried out under conditions of precipitation or bank saturation. There is no significant difference between the moisture contents of February and May 1988 for Plot 5 ($t = 0.630$; d.f. = 21; significance = 0.535). An explanation should be sought as to what changes the bank soil undergoes in relation to other physical properties such as bulk

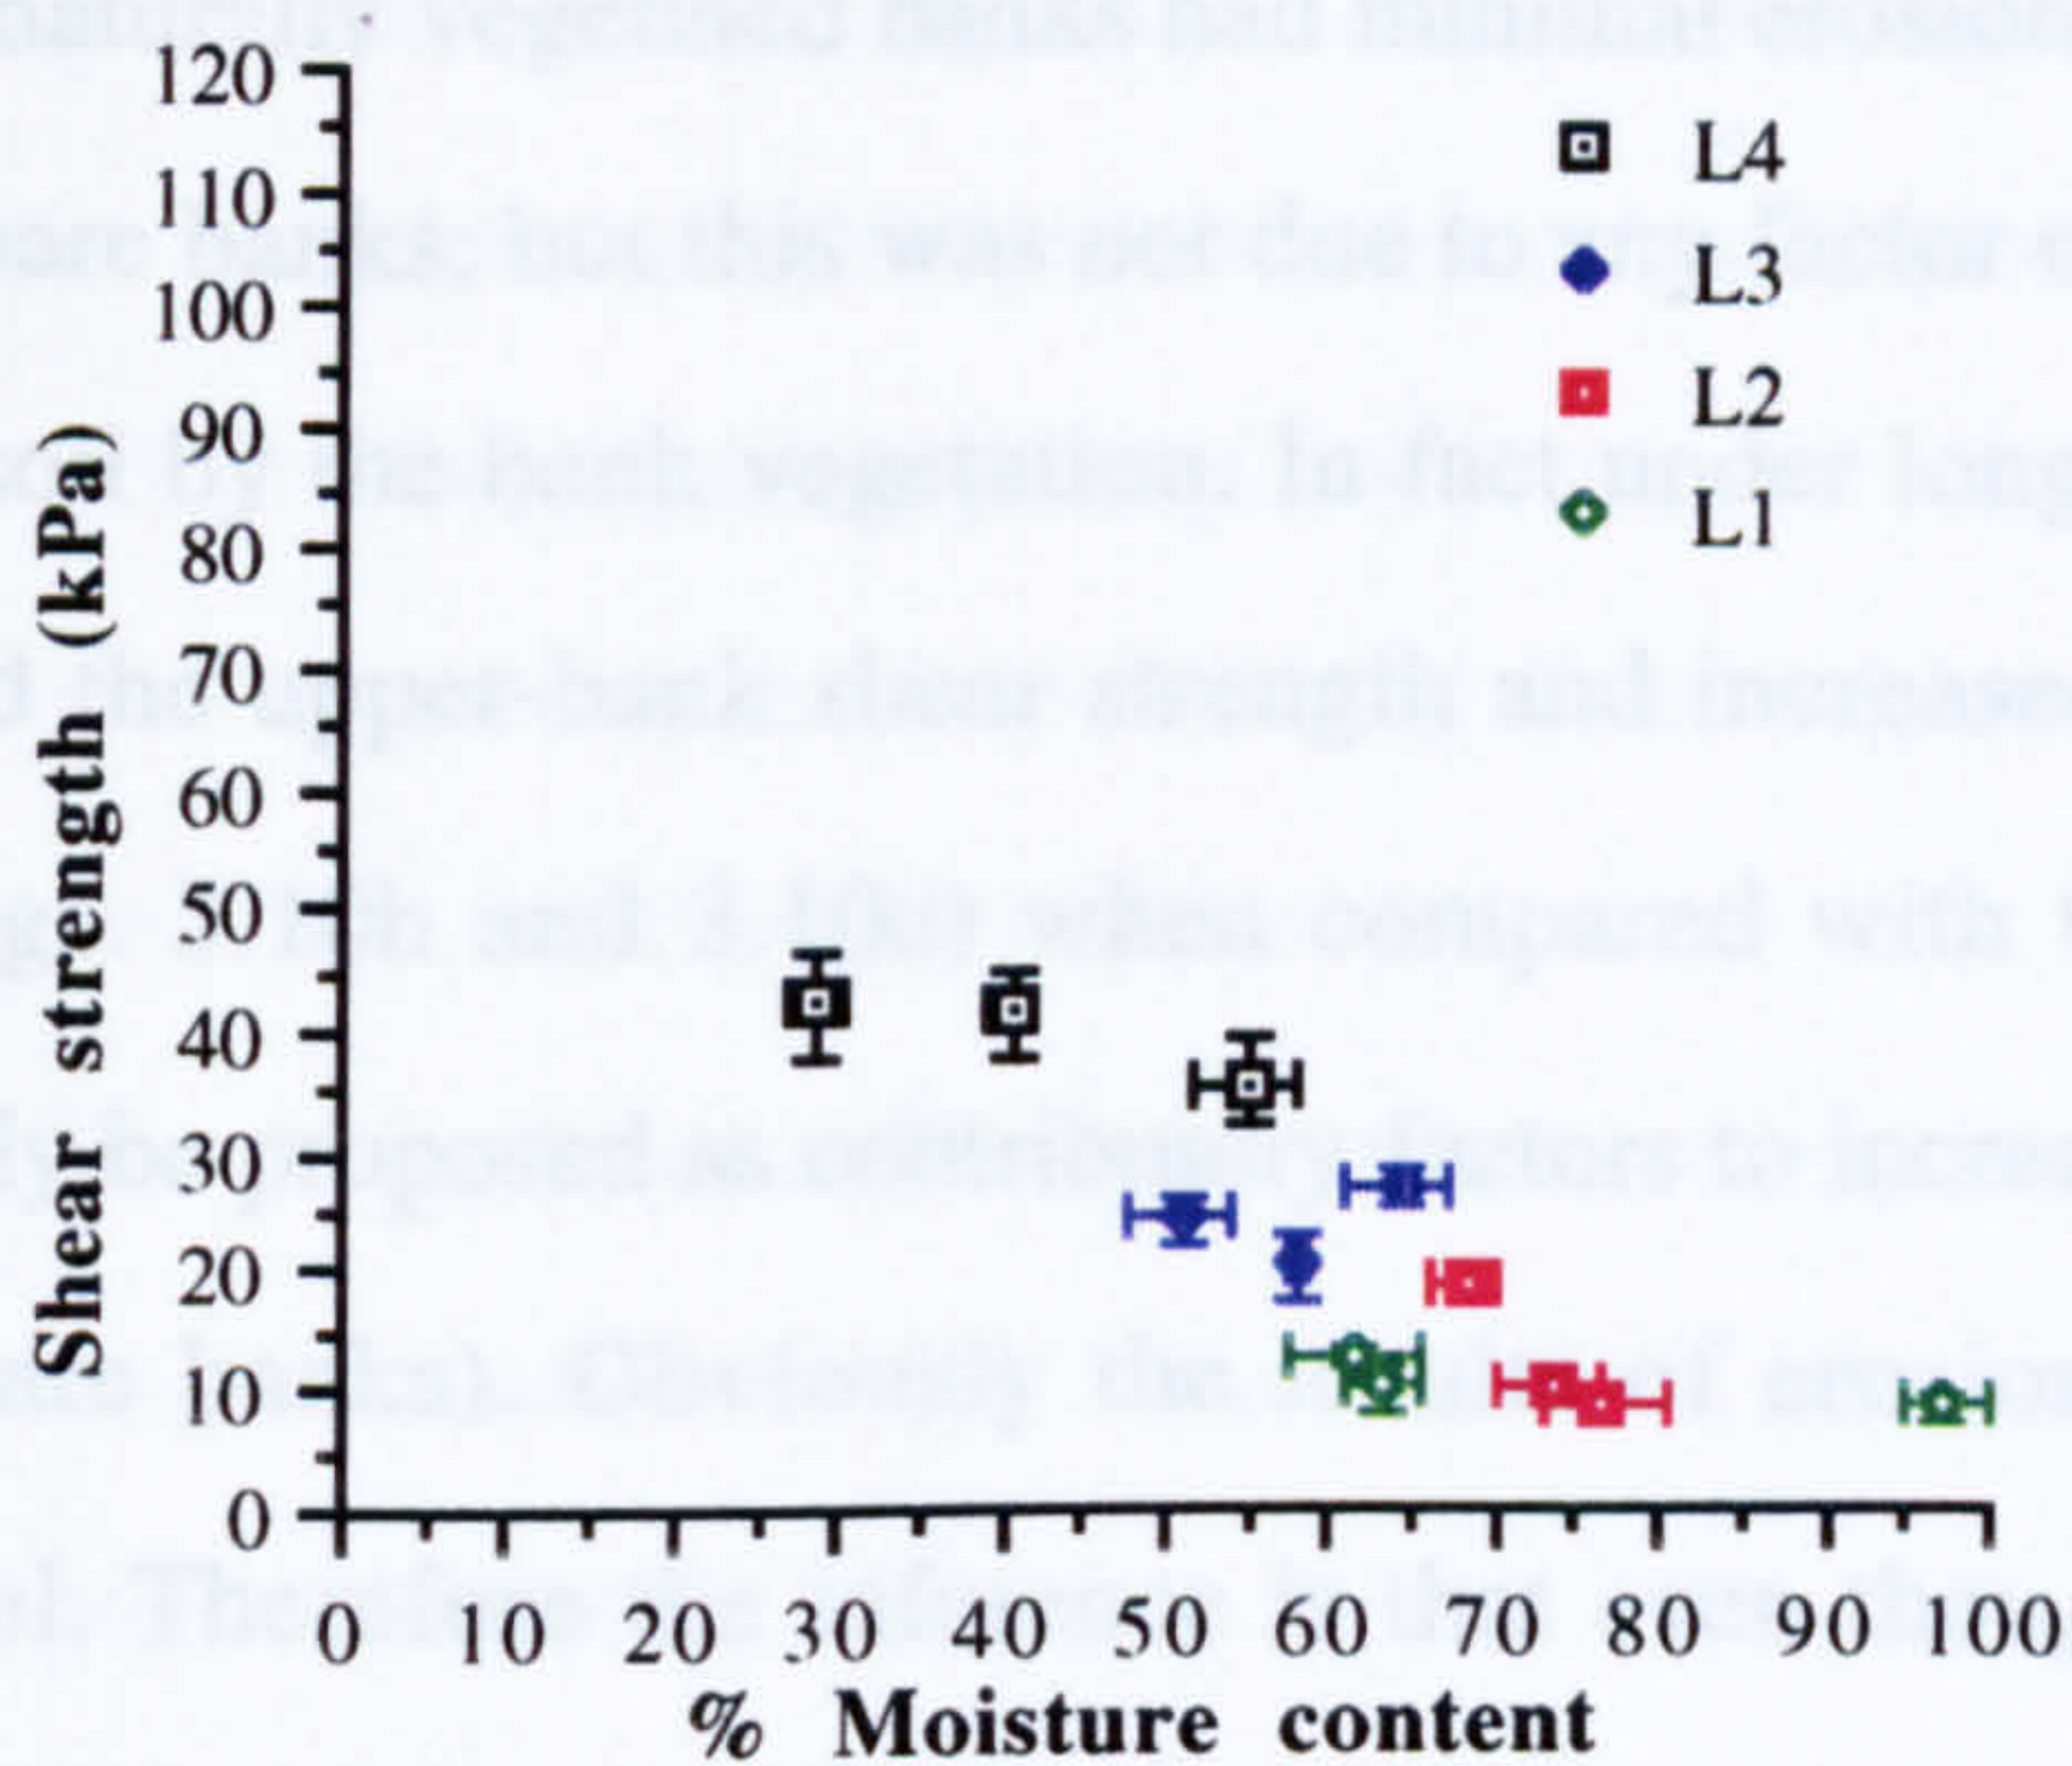
Fig. 3.10b: Shear strength Vs. Moisture content variations (February 1988)
Naturally vegetated banks dominated by *E. hirsutum*

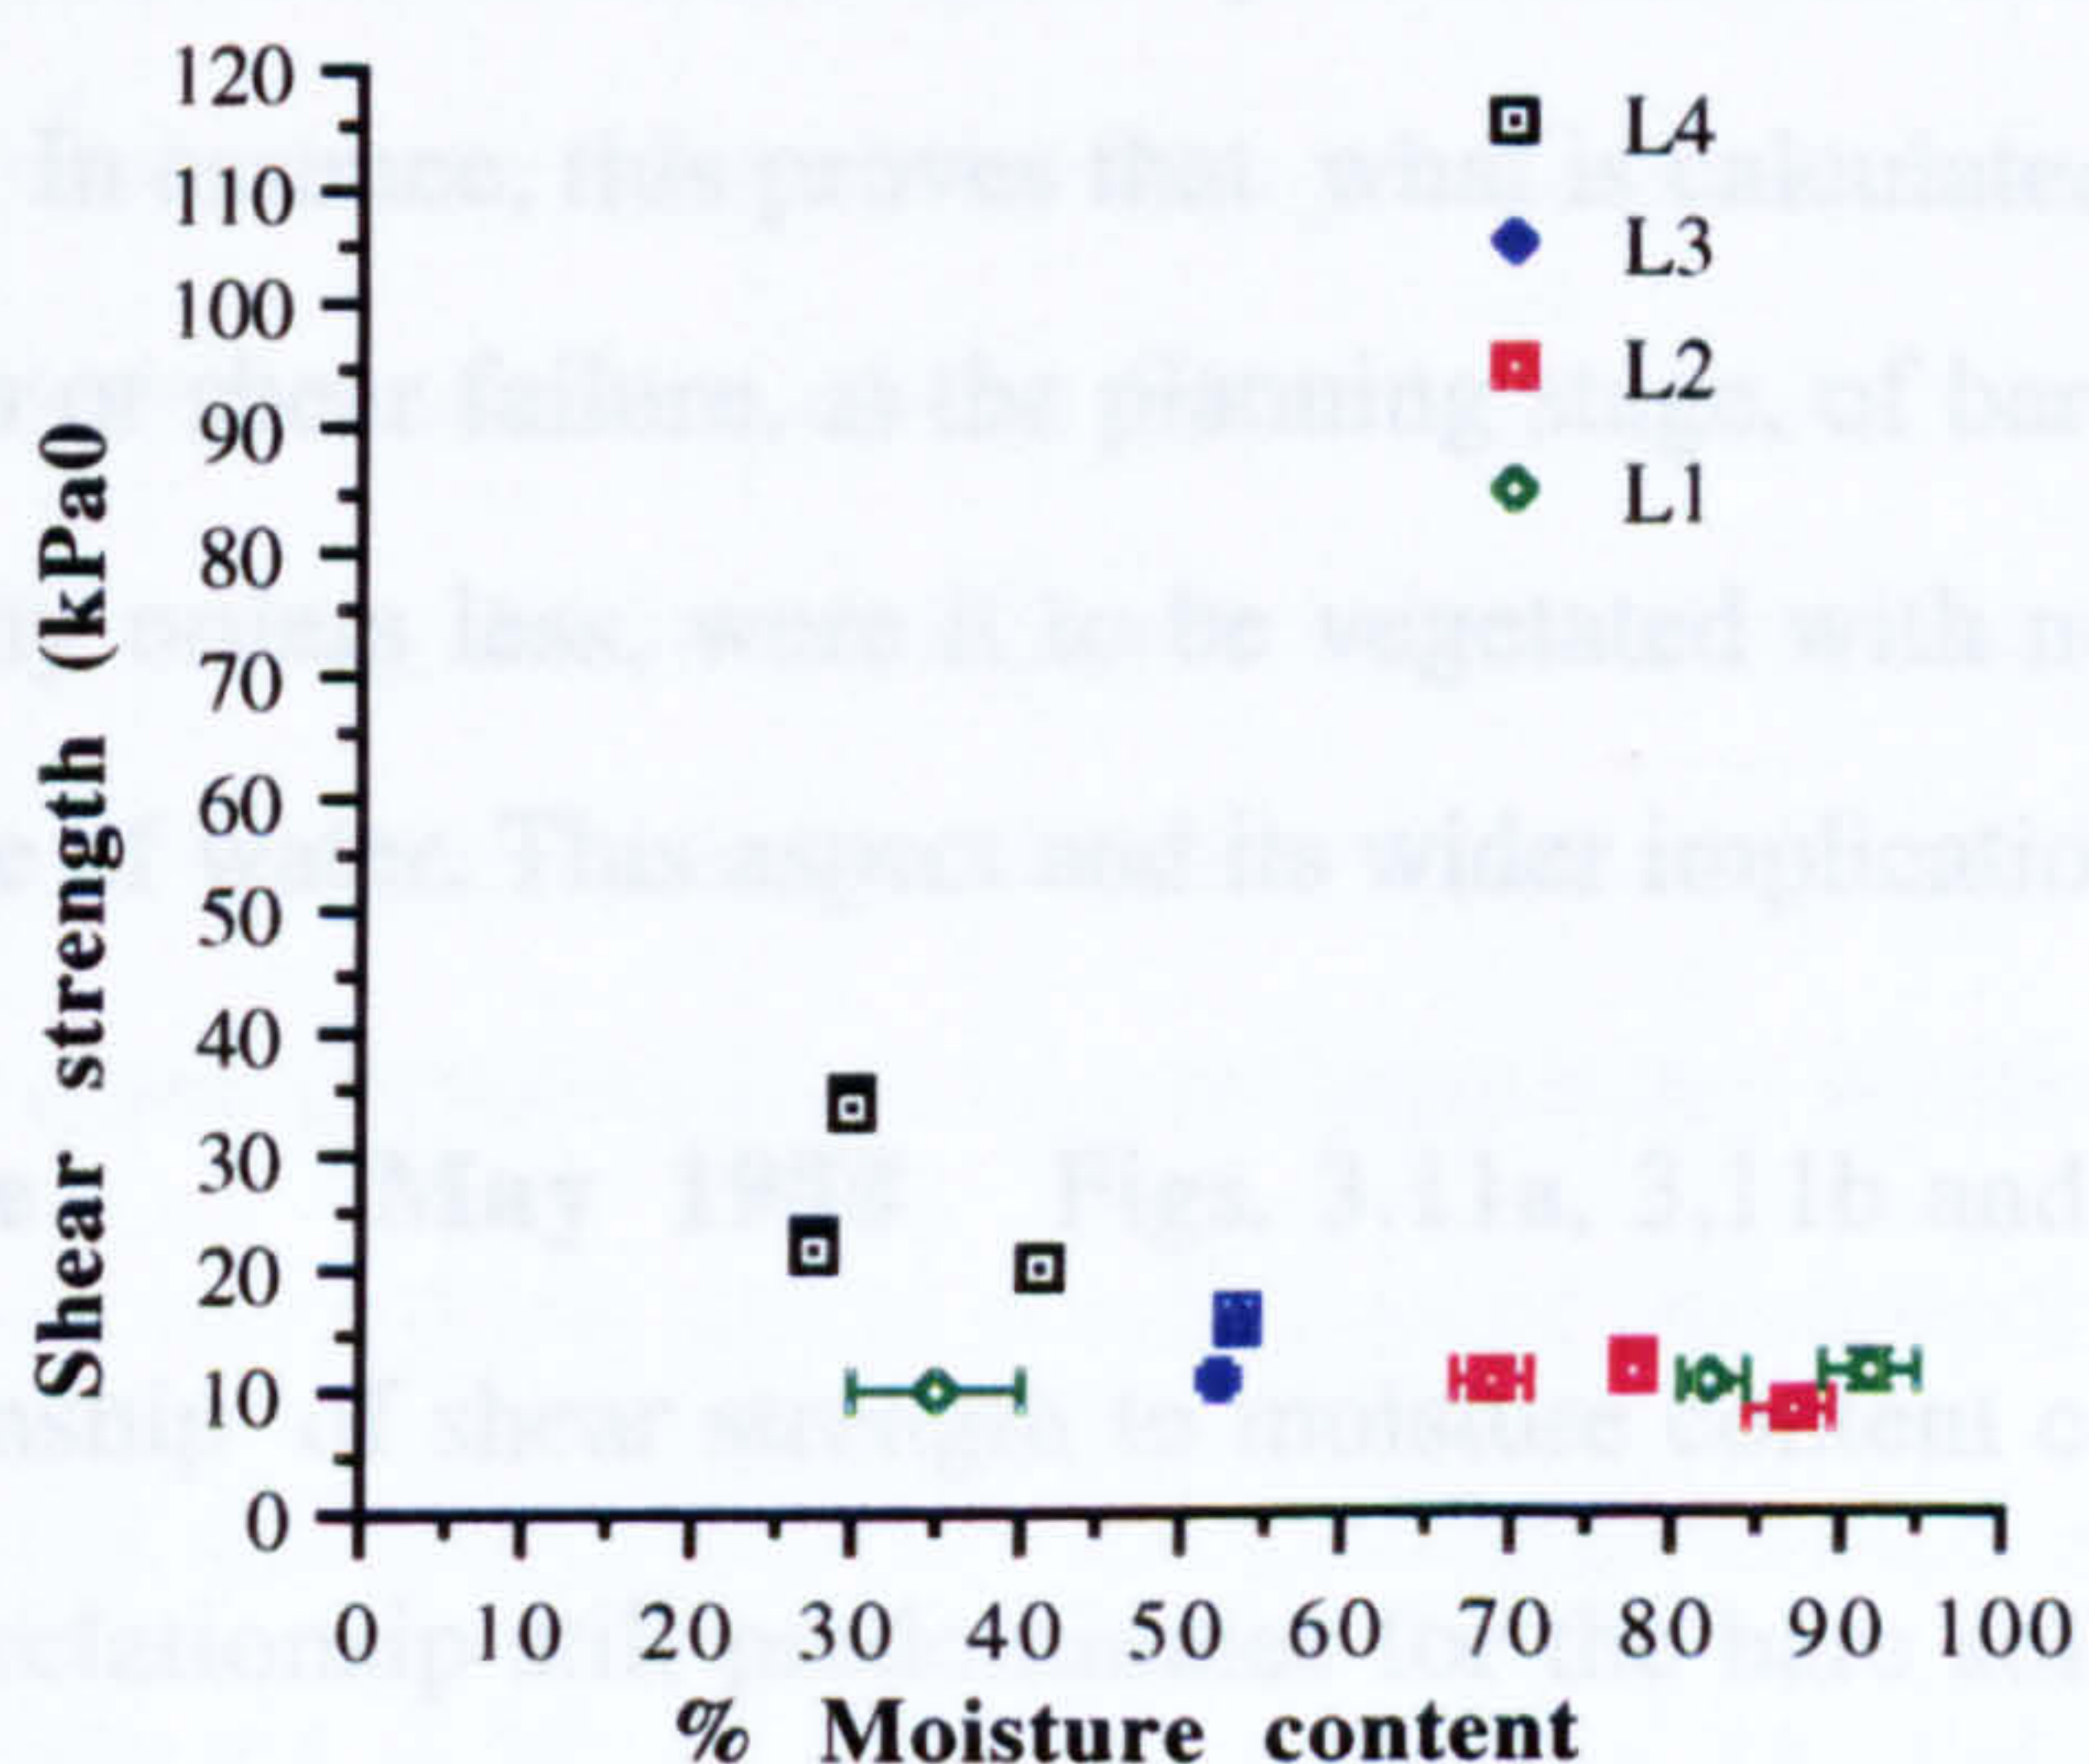
Fig. 3.10c: Shear strength Vs. Moisture content variations (February 1988)
Naturally vegetated banks dominated by *U. dioica*
